Determination of impact and airborne sound insulation of wooden floors in a laboratory according to ISO 140-3 and 140-6.

Christian Berner AB and Getzner Werkstoffe.

Two types of wooden floors with four different types of upper floors.

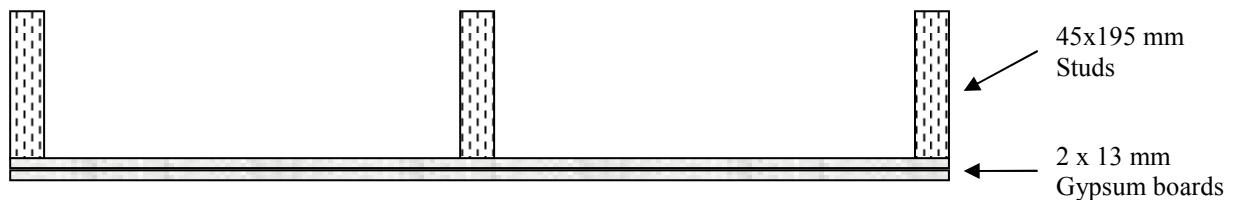
Figure 5 – The **empty** version of the wooden floor structure.

The two wooden floor structures were constructed like Figure 5 and 6.

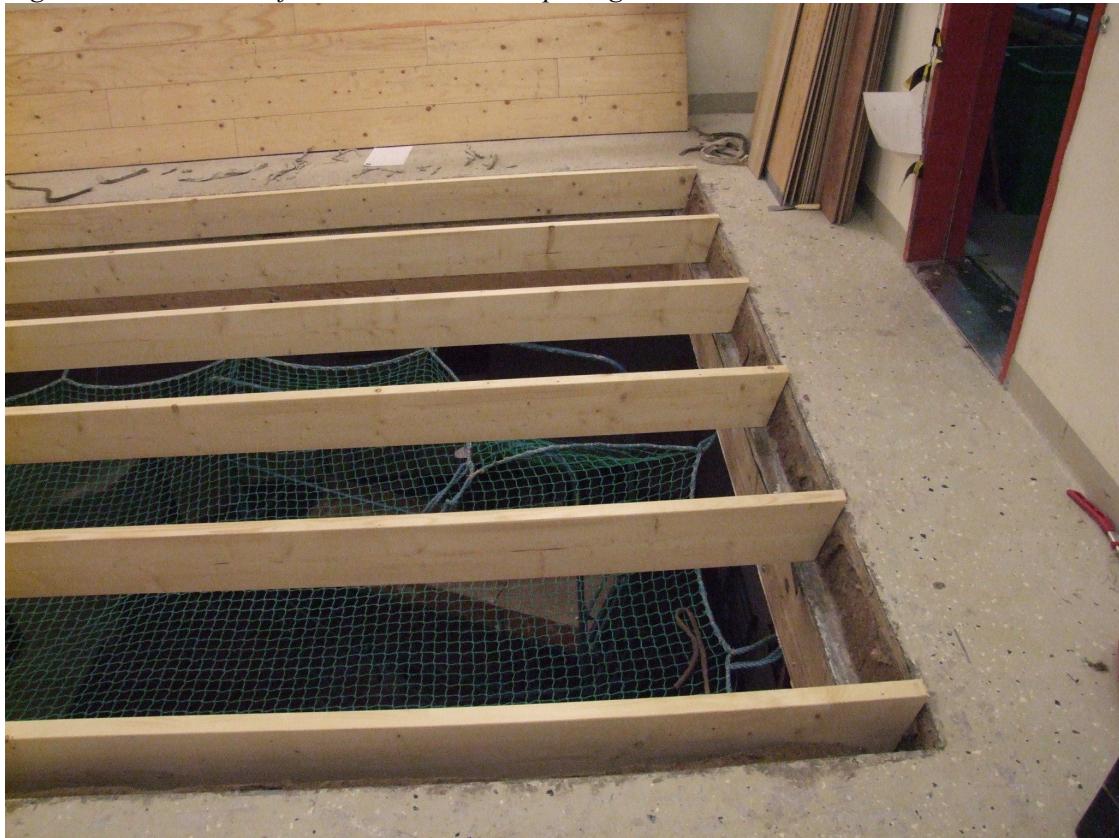
Figure 7 – Placement of the studs in the test opening.

The wooden floor structures where built in SP:s sound insulation laboratory for floors (vertical measurements). The studs where placed directly on the edges of the test opening and can be seen in Figure 7. The mounting of the different upper floors can be seen in Figure 9-18. The joint between the upper floor and a the “real” floor in the laboratory was covered by several strips of gypsum boards and then sealed by tape (made of an elastic woven material) and model clay (see Figure 10).

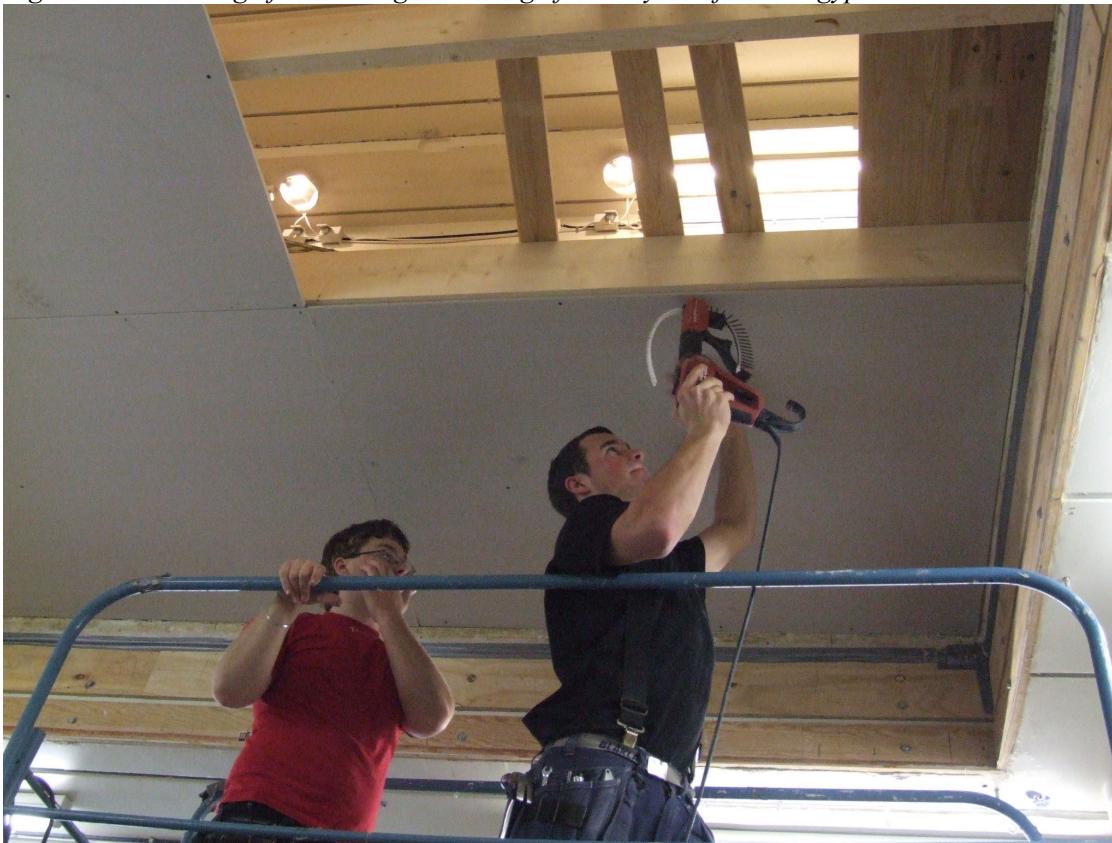
Figure 8 – Mounting of the ceiling consisting of two layers of 13 mm gypsum boards.

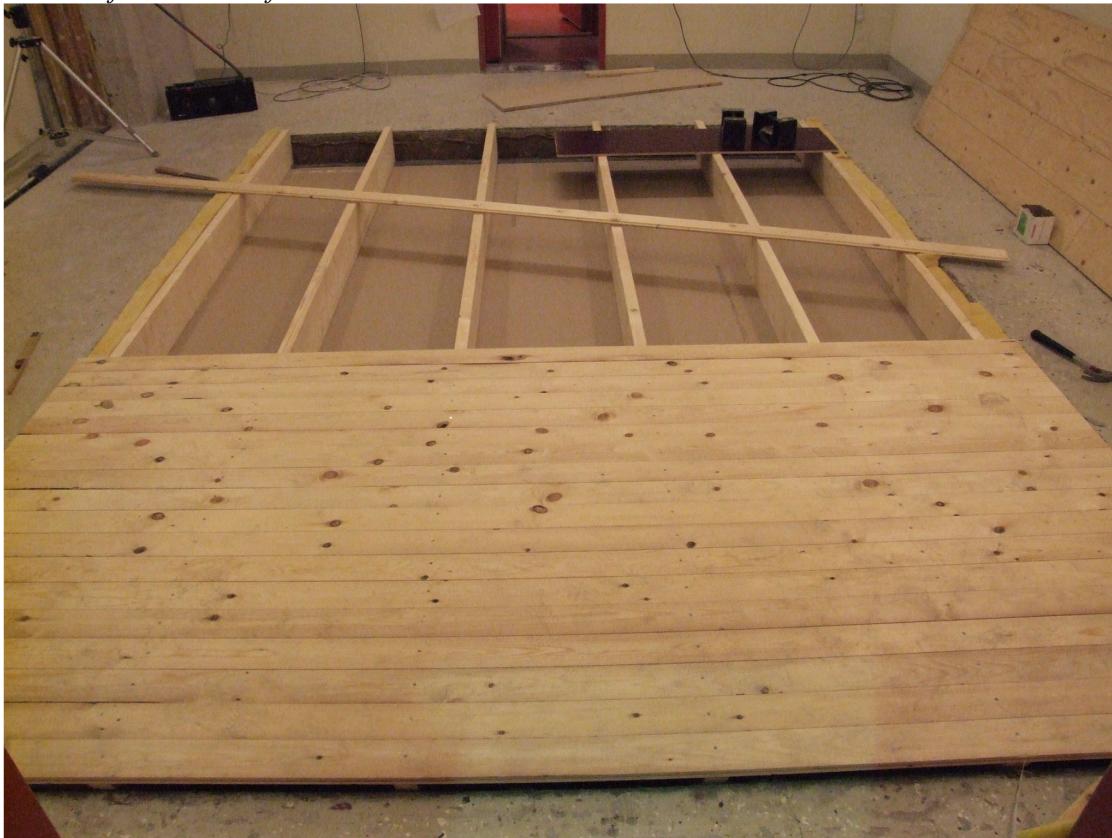
Figure 9 - Building of the first upper floor (22 mm tongued and grooved board) on the empty version of the wooden floor structure.

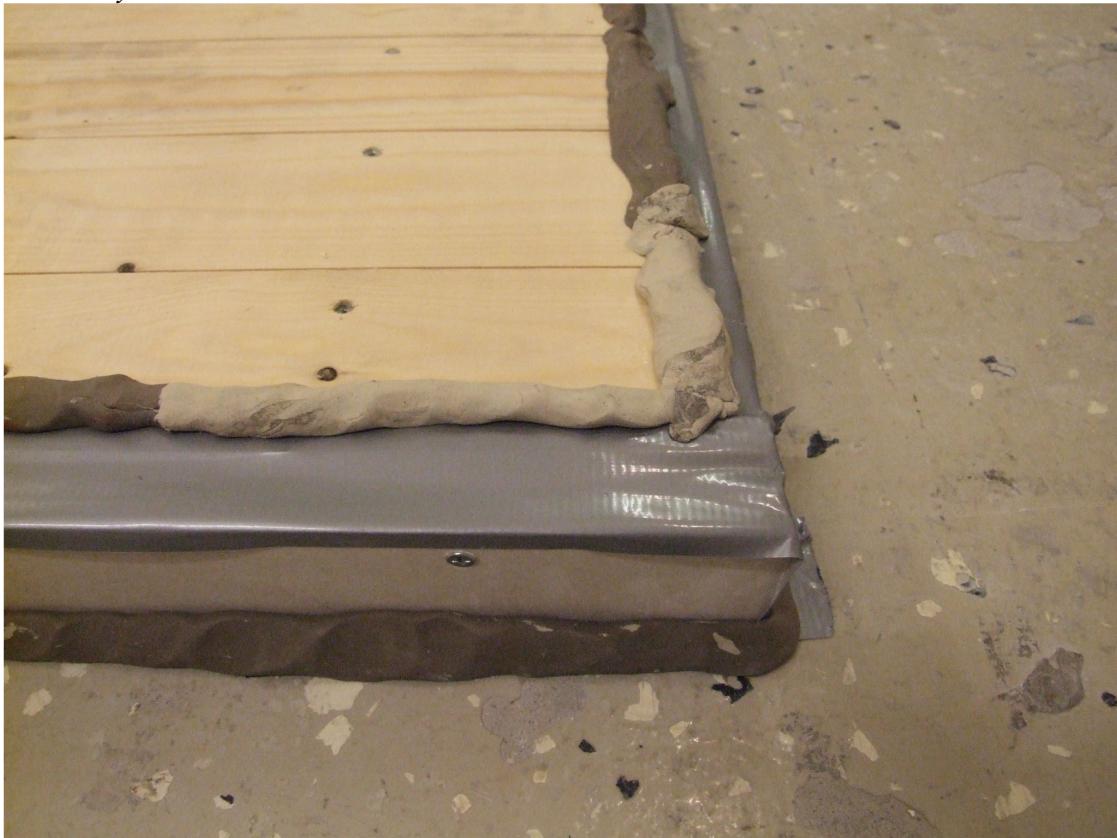
Figure 10 – Closing of the upper floor consisting of strips of gypsum board, tape and model clay.

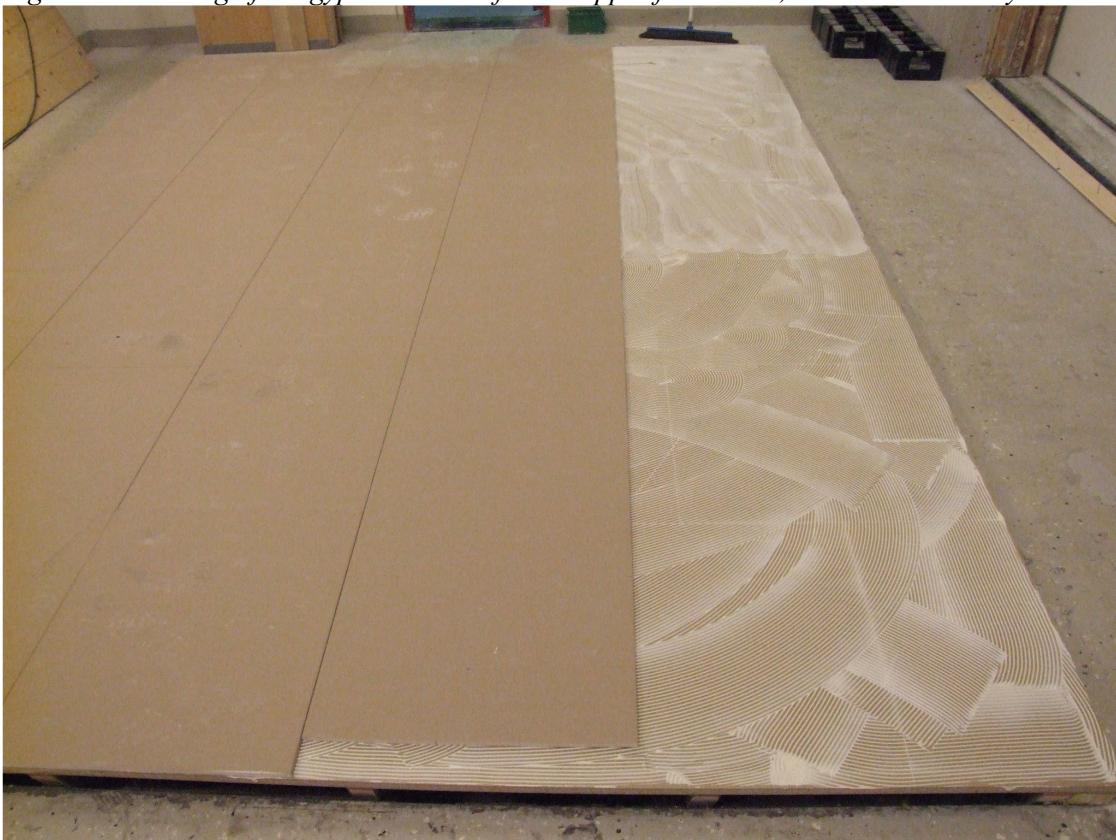
Figure 15 – Gluing of the gypsum boards for the upper floors P12, L25 and L25 heavy.

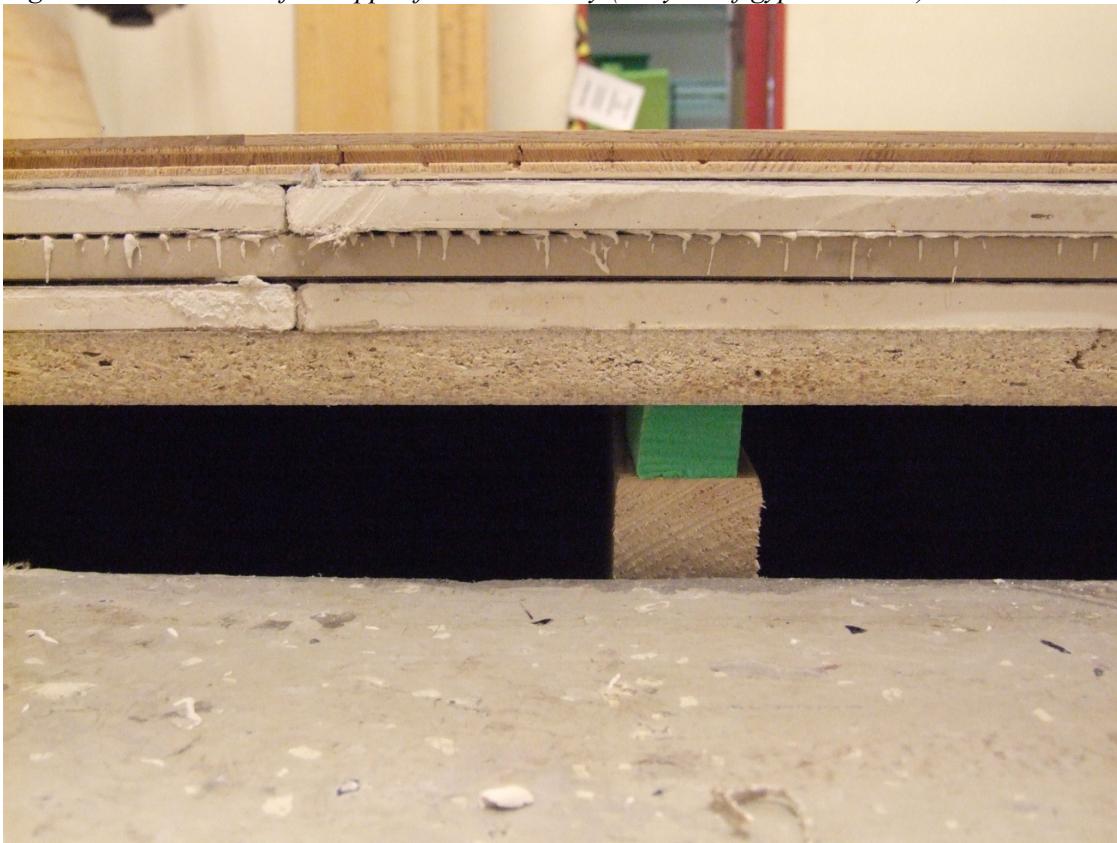
Figure 16 – Side view of the upper floor L25 heavy (3 layers of gypsum board).

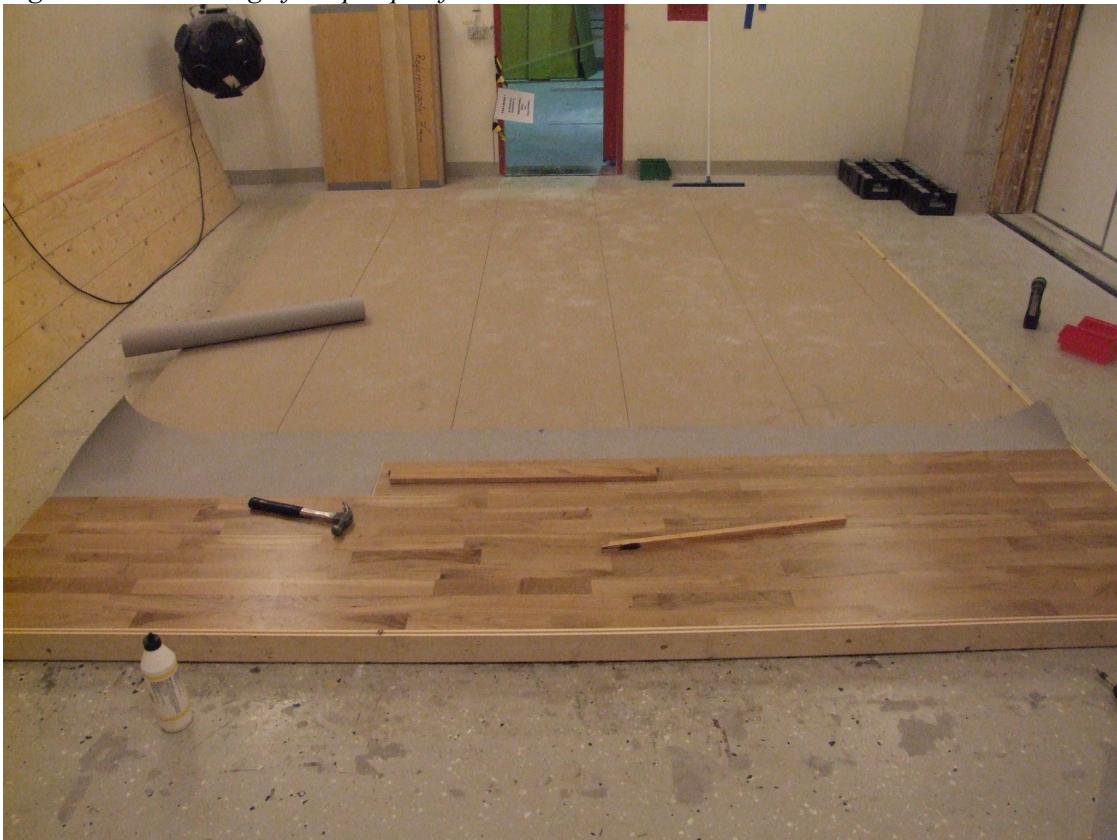
Figure 17 – Mounting of the parquet floor.

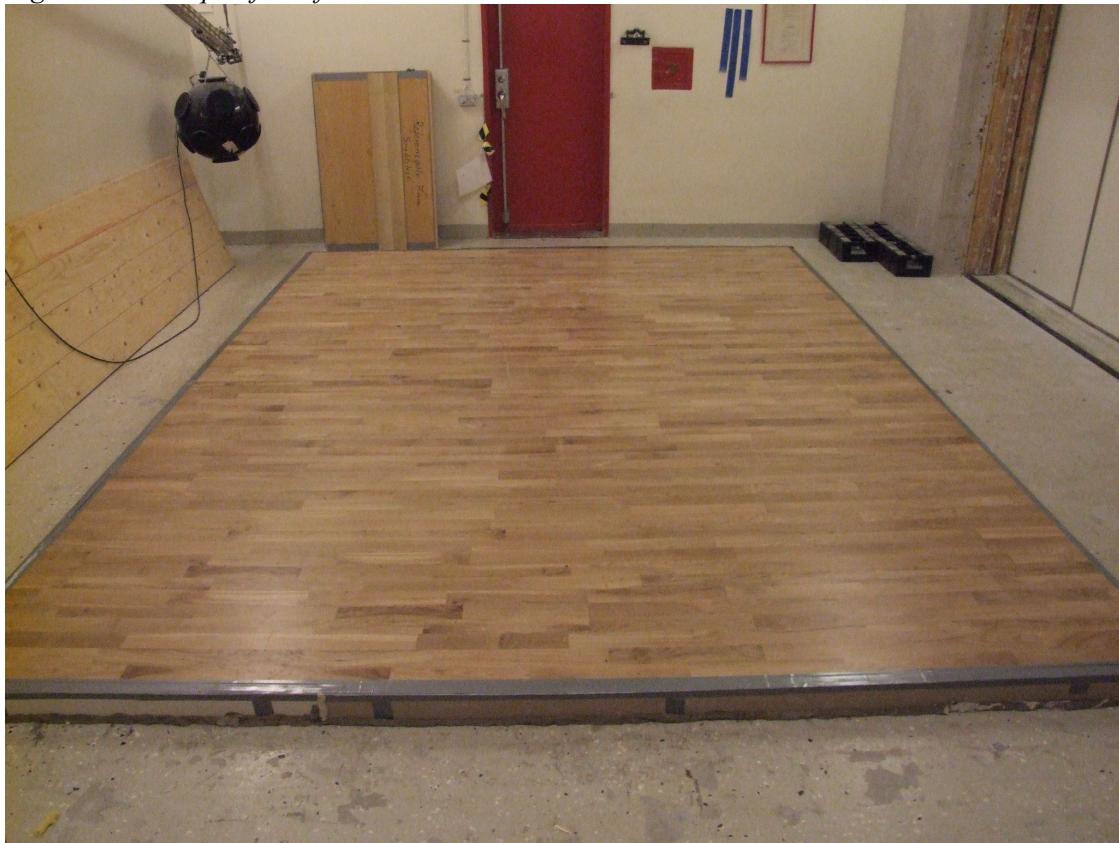
Figure 18 – Parquet floor finished..

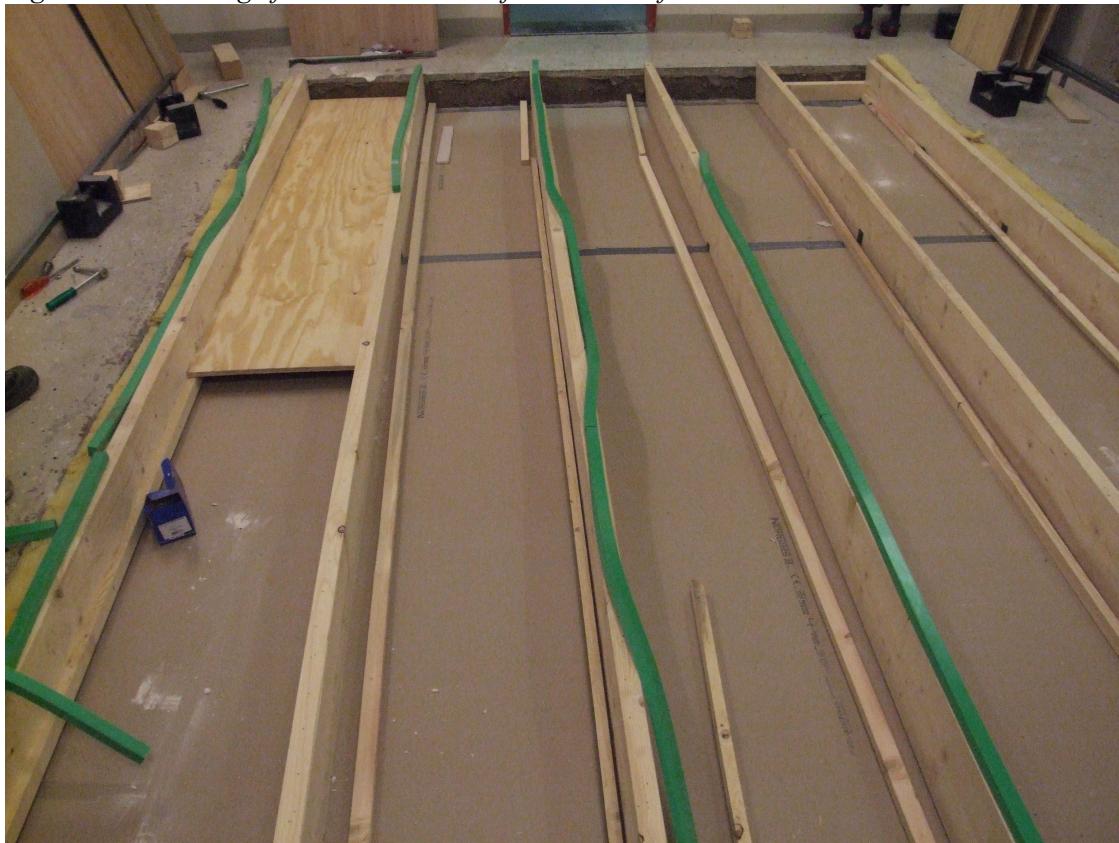
*Figure 19 – Building of the sand version of the wooden floor structure.*

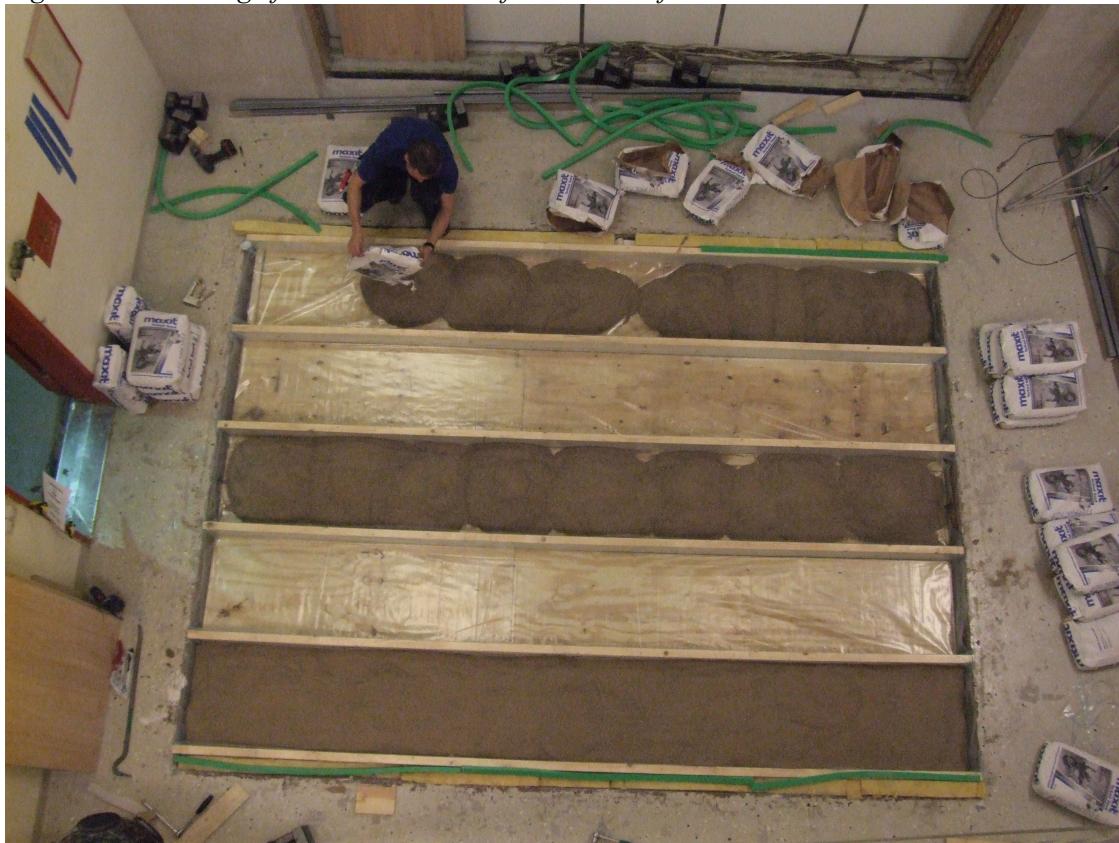
Figure 20 – Building of the sand version of the wooden floor structure.

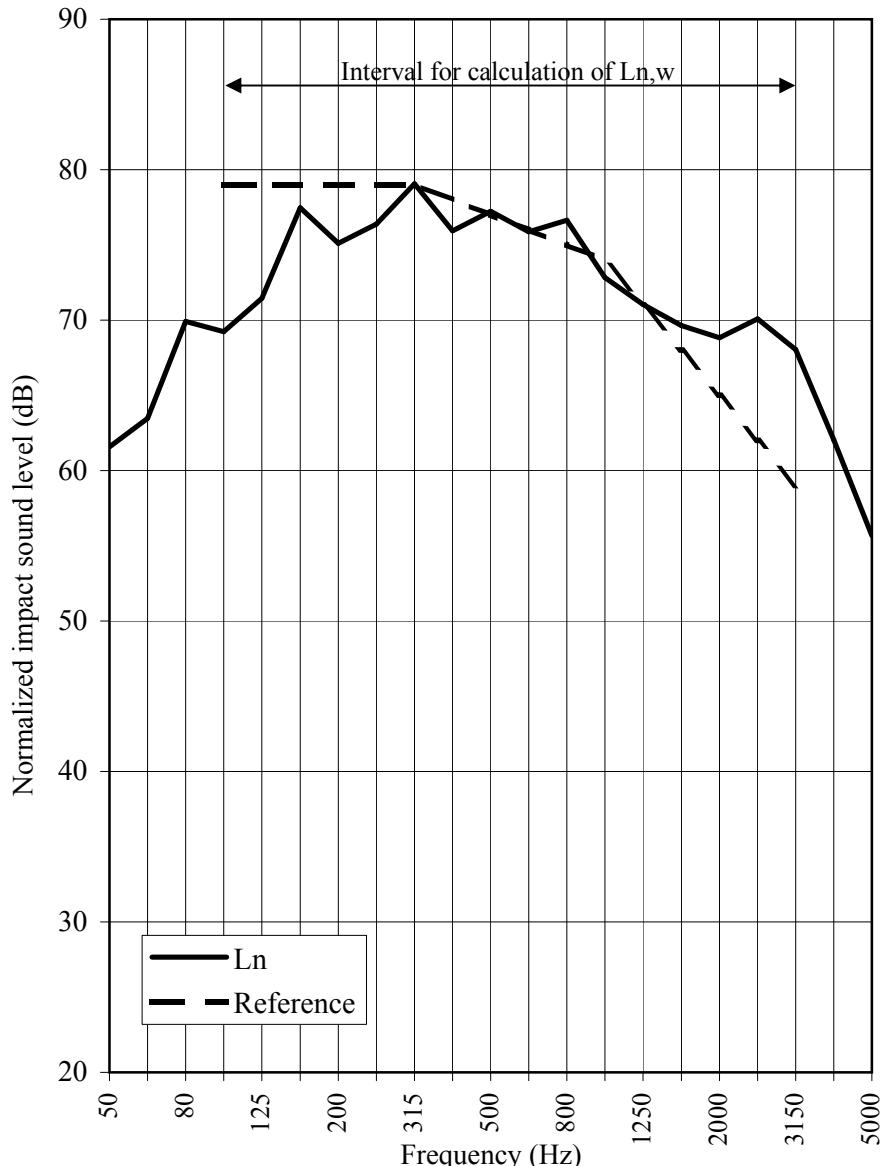
Enclosure 9

Measurement object: 22 mm tongued and grooved board + sand version of the floor structure

Volume of R-room: 138 m³Results: Weighed impact sound level, L_{n,w} and adaption terms, C_I & C_{I,50-2500}

L _{n,w}	77
C _I	-5
C _{I,50-2500}	-5
Sum. dev.	24,6
Max. dev.	9,1
Frequency	3150
